Vincenzo Riso

Álvaro Siza's Lordelo do Ouro Cooperative Building

Álvaro Siza's Lordelo do Ouro Cooperative Building: Preliminary Studies towards the Conservation of a Masterpiece in Need of Recognition

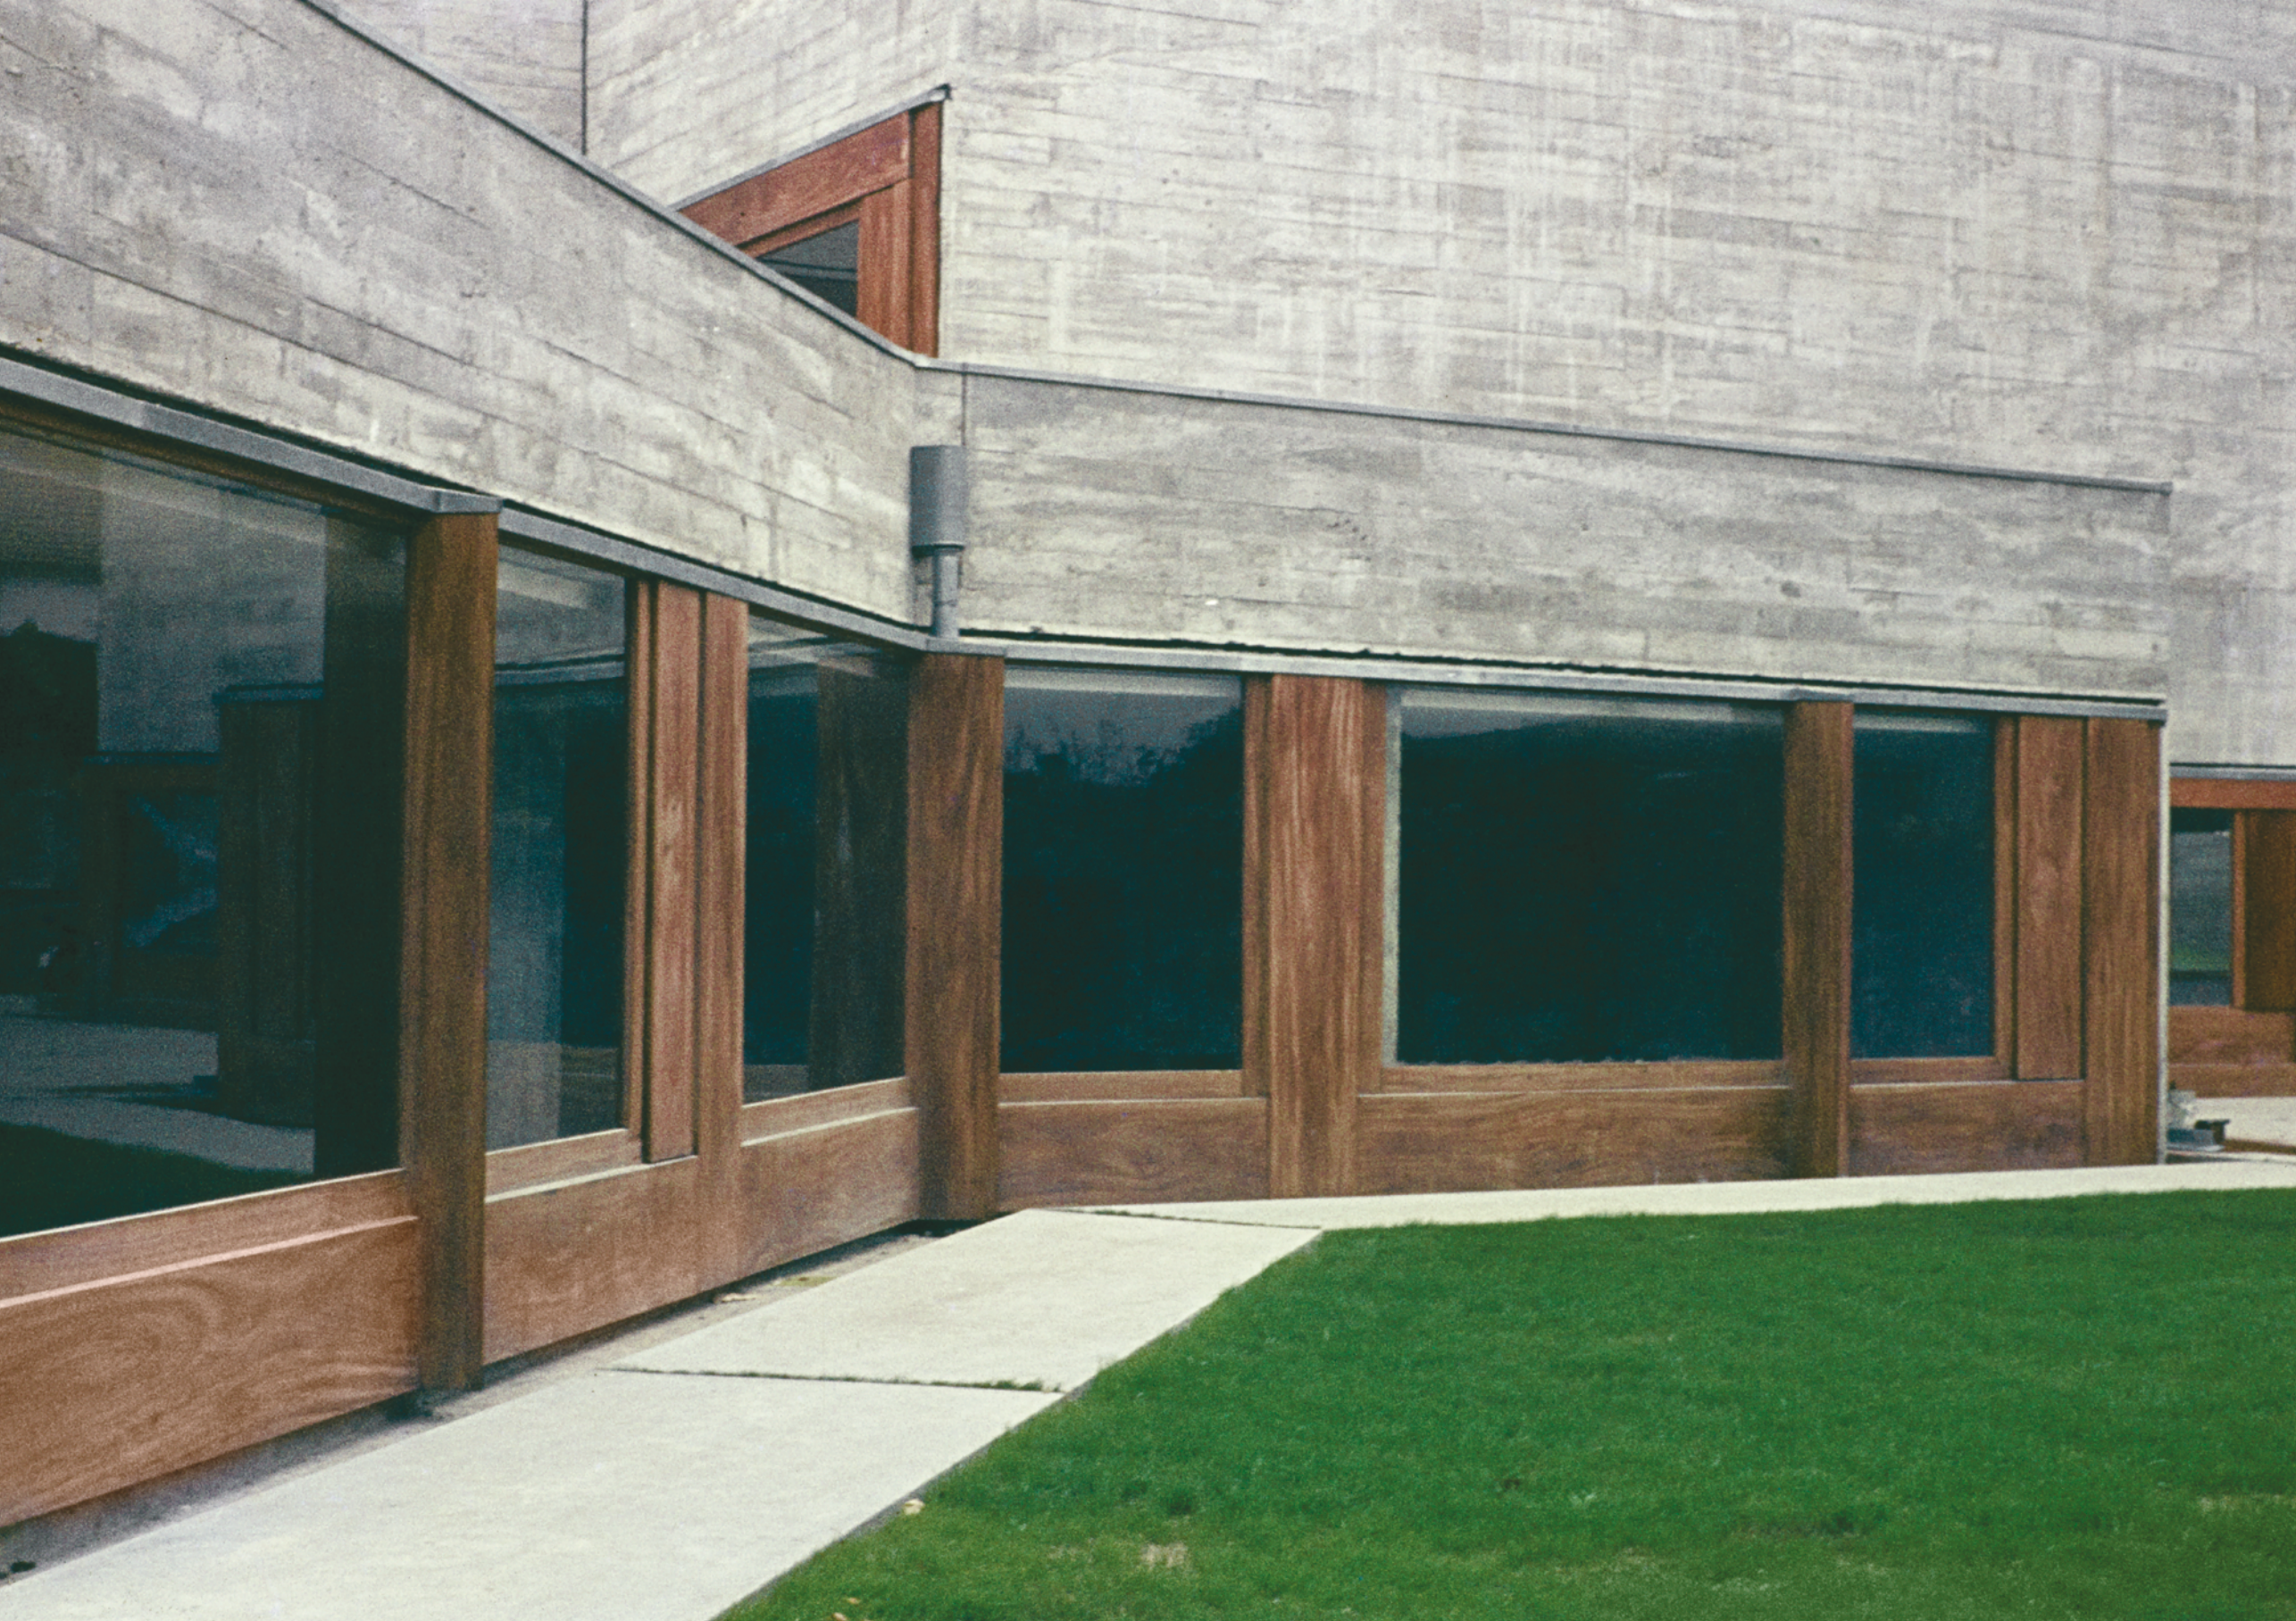
Fig. 0.0
Rare color picture of
the Lordelo do Ouro
Cooperative Building that
illustrates it in its original
features and condition
(Jorge Gigante 1967,
collection and courtesy
of the author's family)

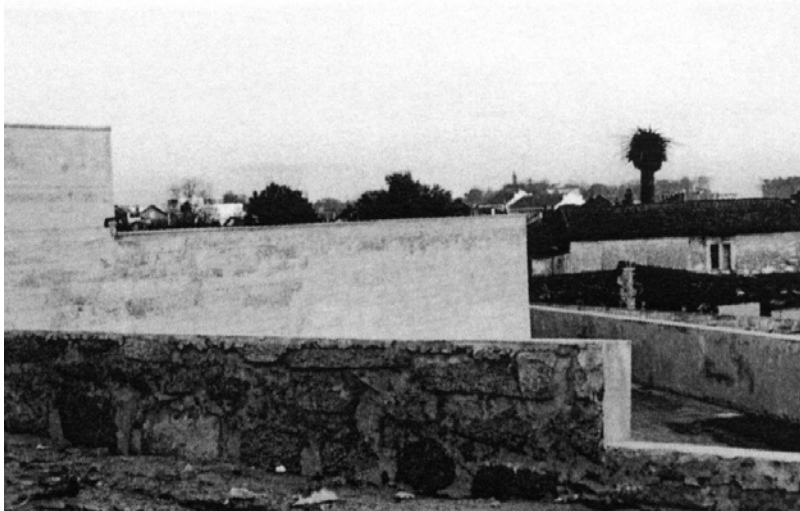
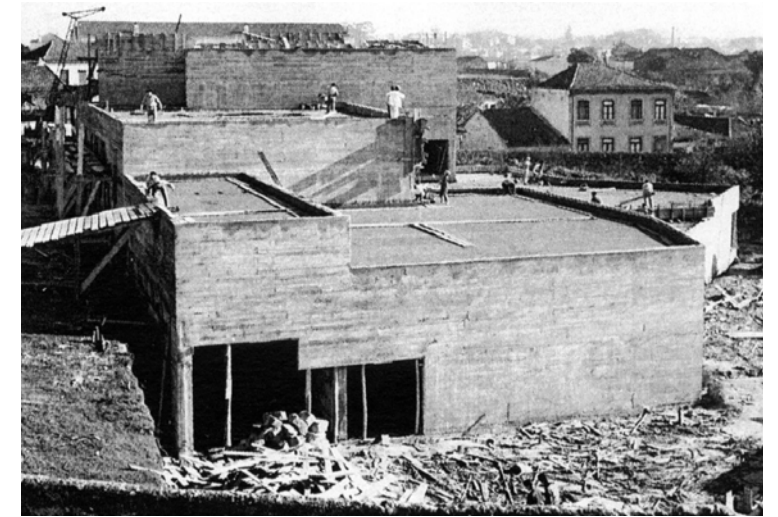
Figs. 0.1 a/b/c
The surrounding context in the western part of the city of Porto in 1960-63.

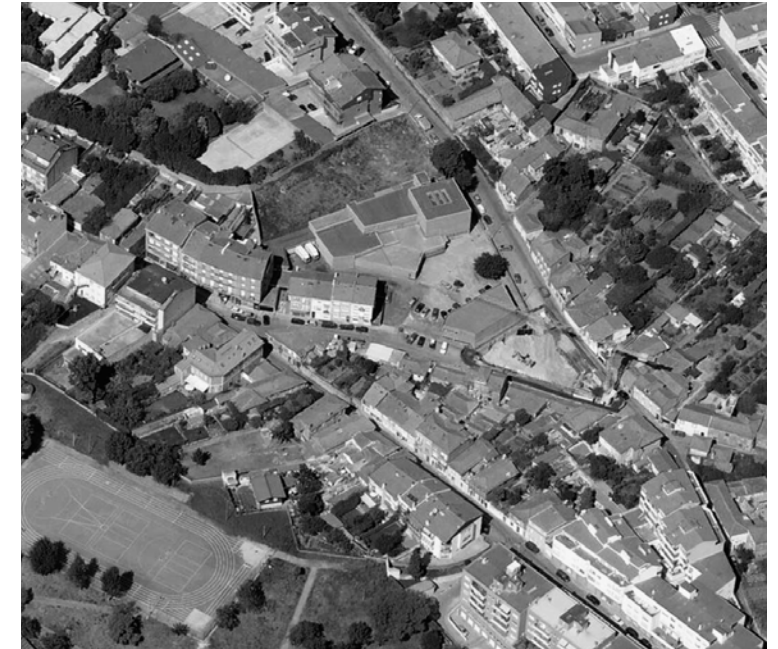
Fig. 0.1 d
The surrounding context in the western part of the city of Porto in 2018 (aerial view DGTerritório).

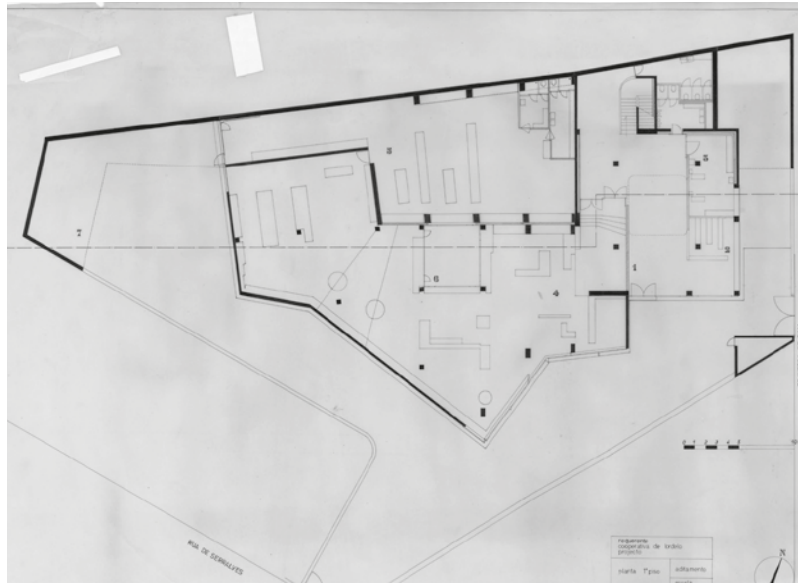
Figs. 0.2 a/b/c
Original ground
and first floor plans.
(with longitudinal section)
© General Archive
of the city of Porto.

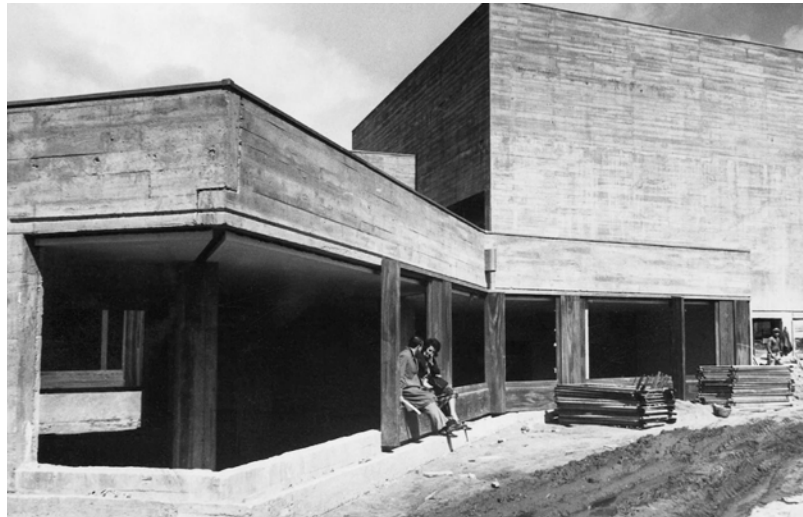
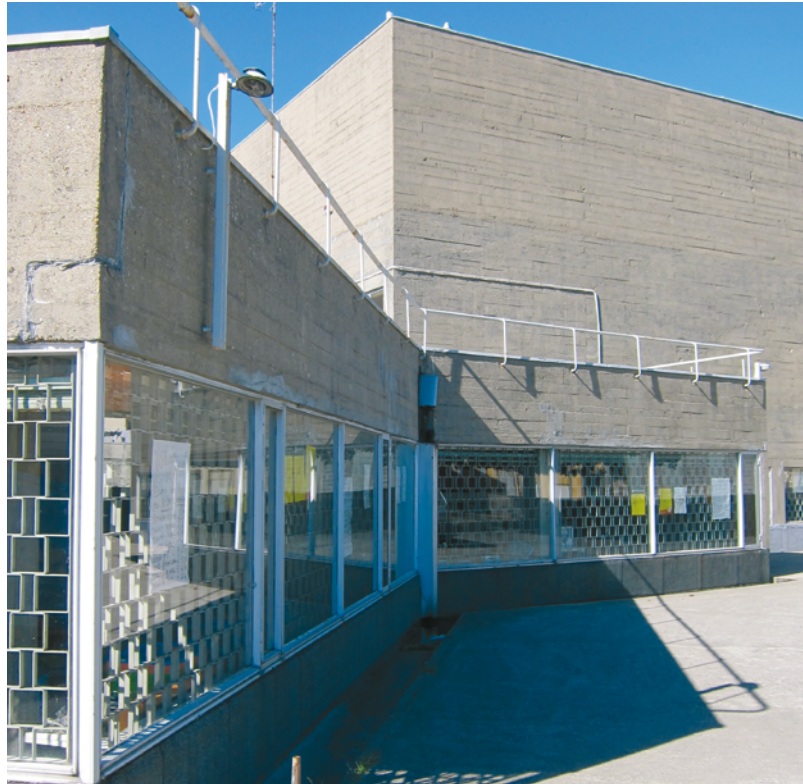
Figs. 0.4 a/b
Foreshortenings of
the South elevation.

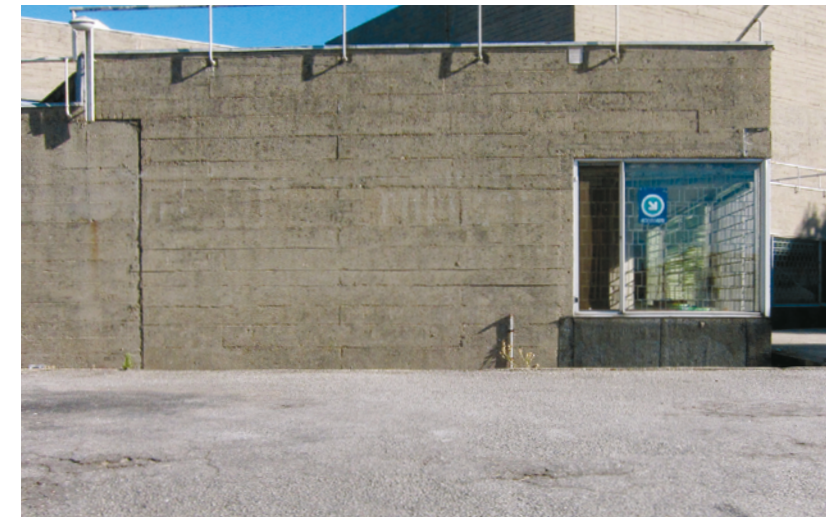
Figs. 0.5 a/b
Frontal views of
the West elevation.

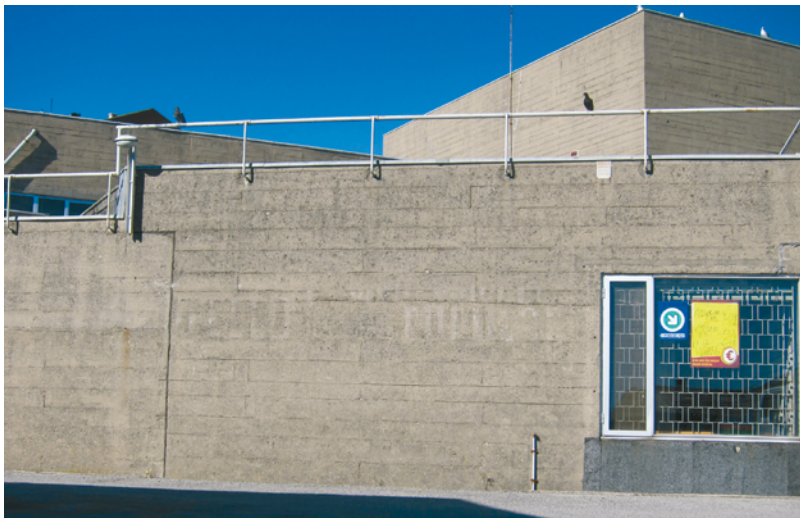
Figs. 0.6 a/b
Full views of
the West elevation.

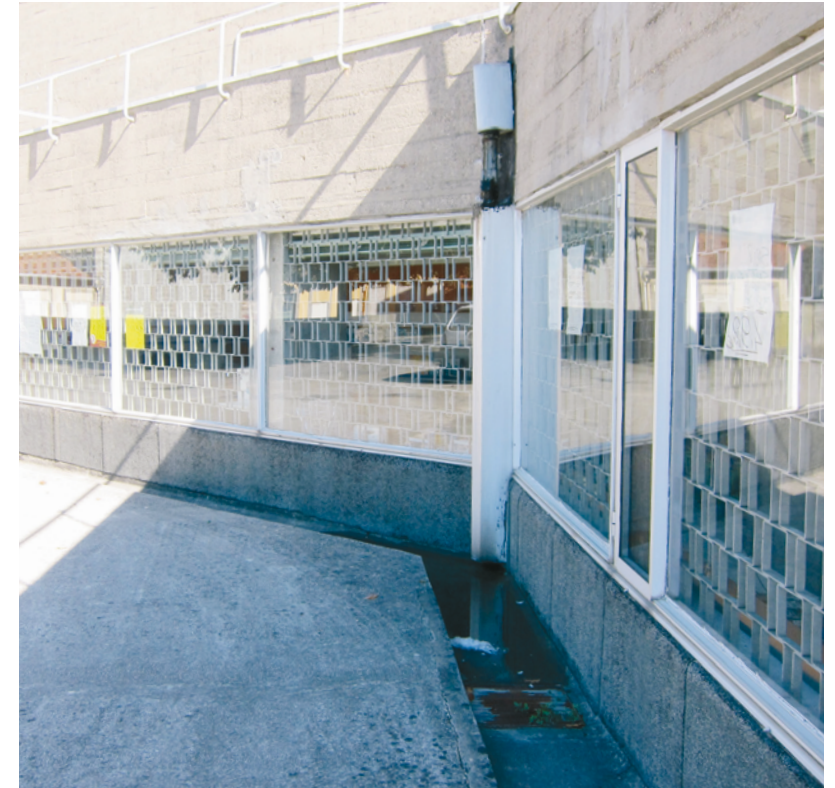
Figs. 0.7 a/b
Detailed views of
the South elevation.

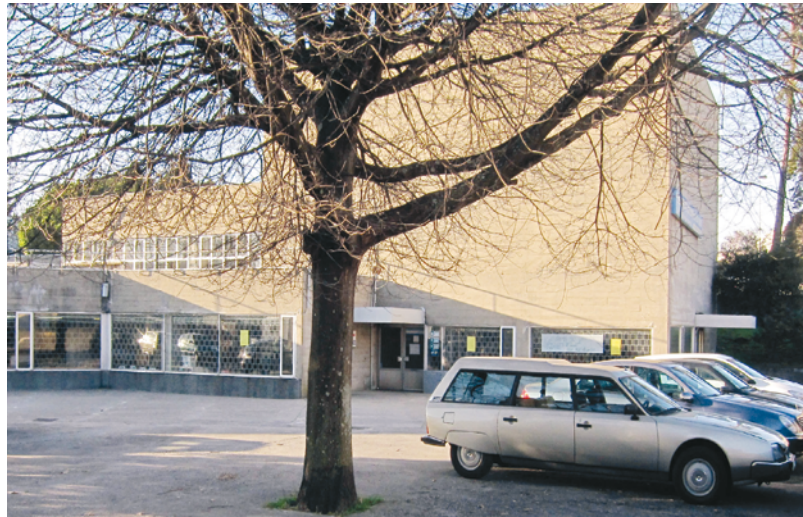
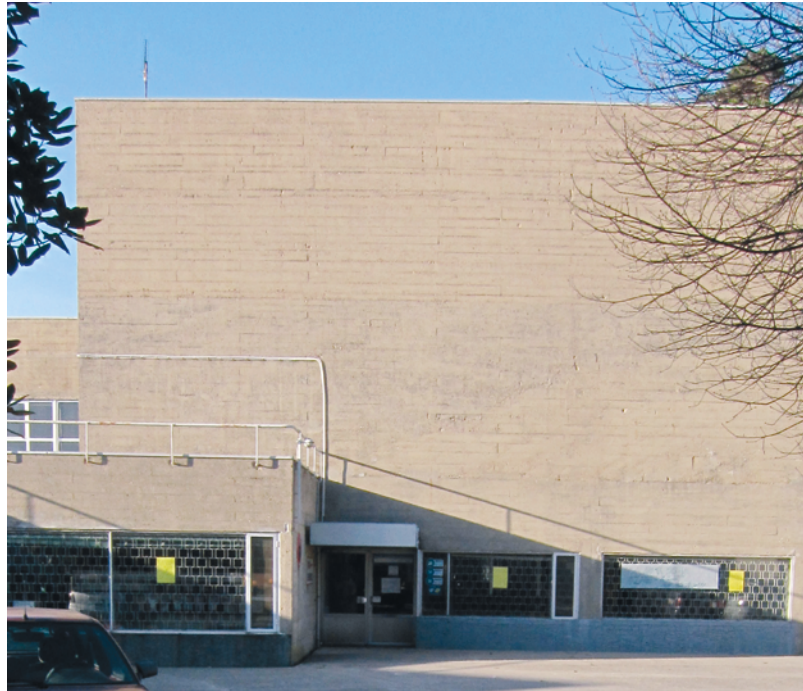
Figs. 0.8 a/b
Foreshortening and
frontal detail view of
the South elevation.

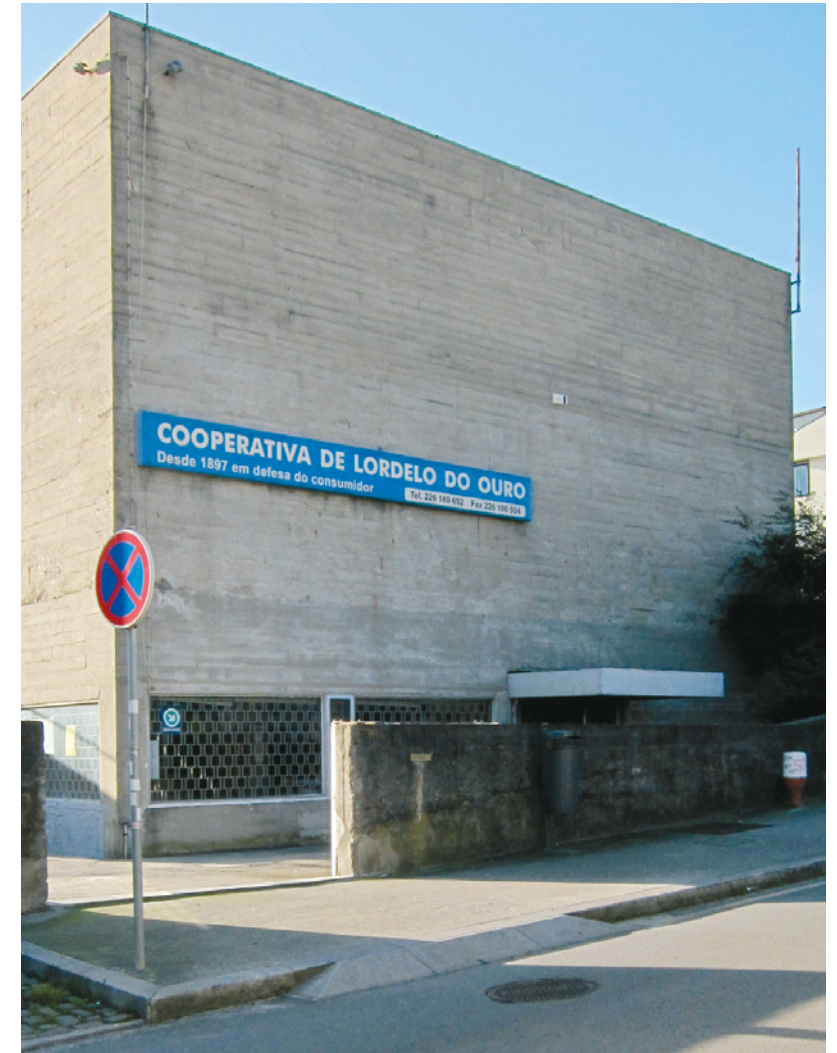
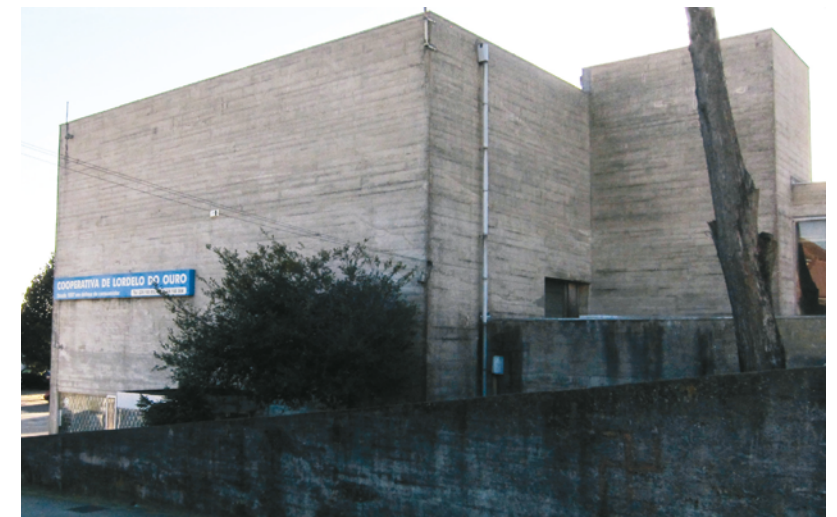
Figs. 0.9a/b
Foreshortening
(from opposite sides)
of the East elevation.

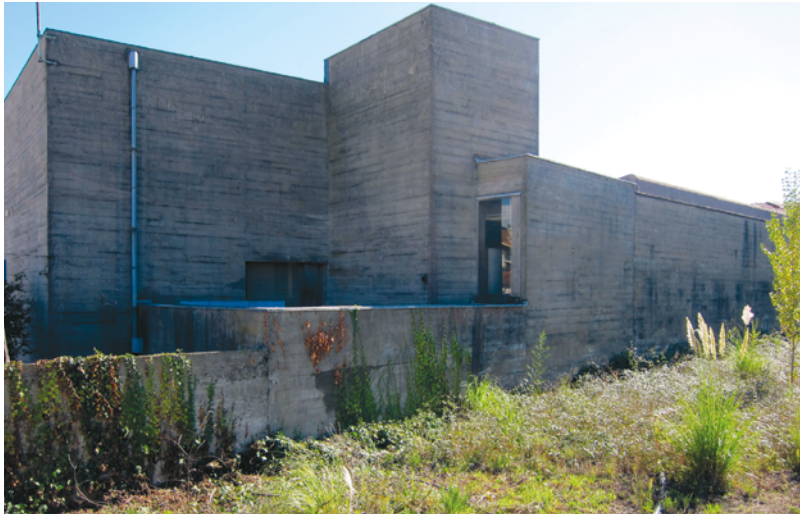
Figs. 0.10 a/b
Foreshortenings
(from opposite sides)
of the North elevation.

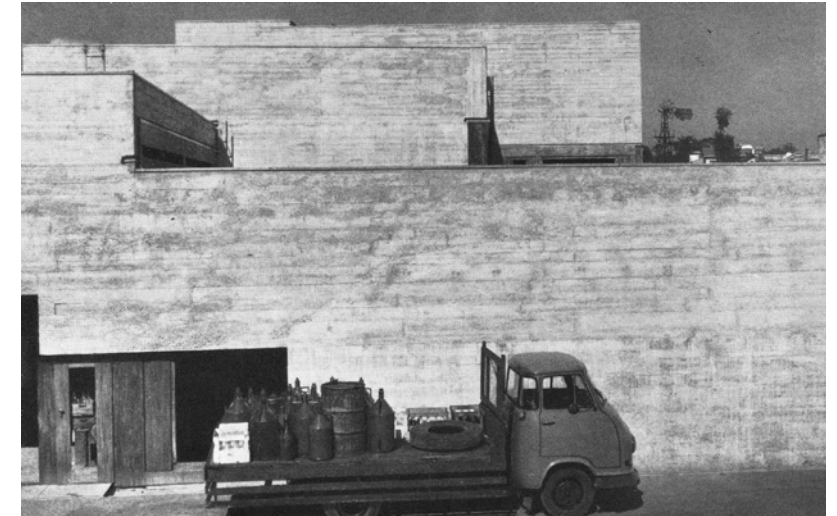
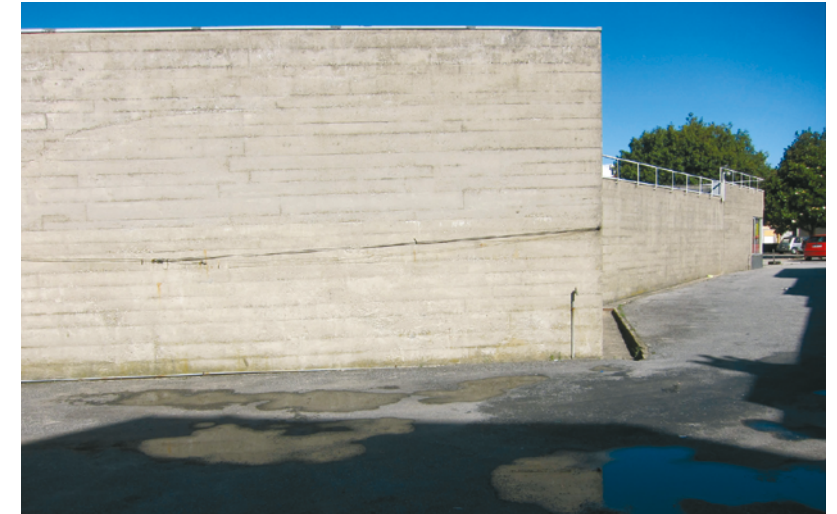
Figs. 0.11 a/b
Detailed views of
the West elevation.

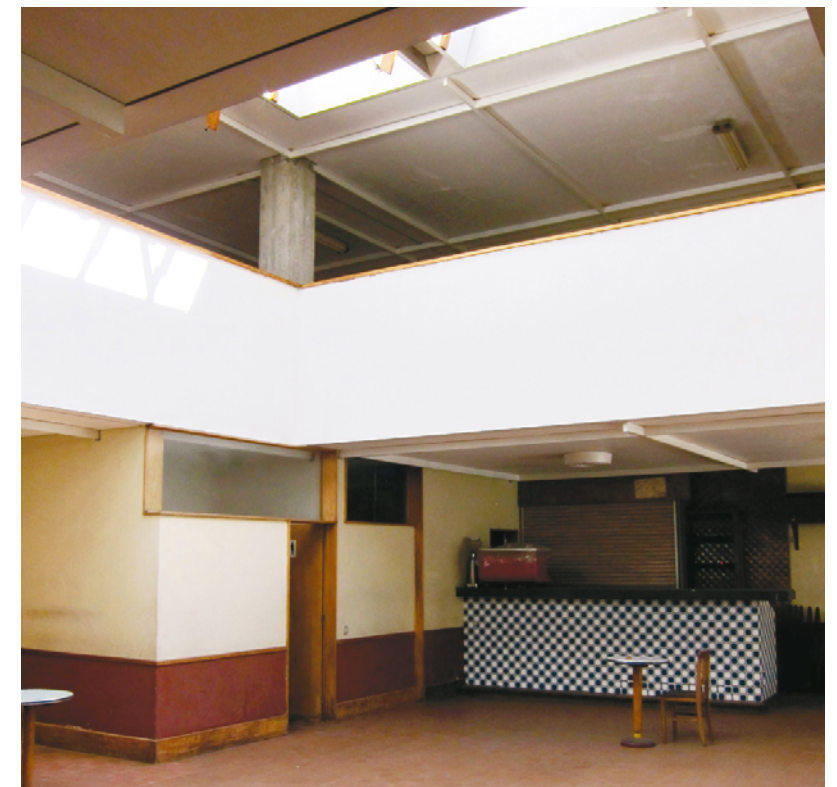
Figs. 0.15 a/b
Original three-story high
sky-lit atrium in the taller
cubic block and after
it was sealed off at first
floor level.

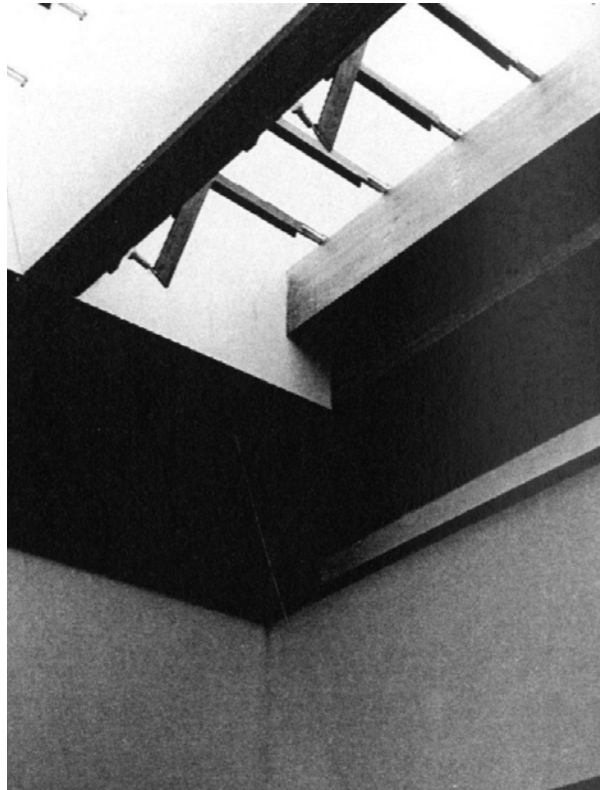
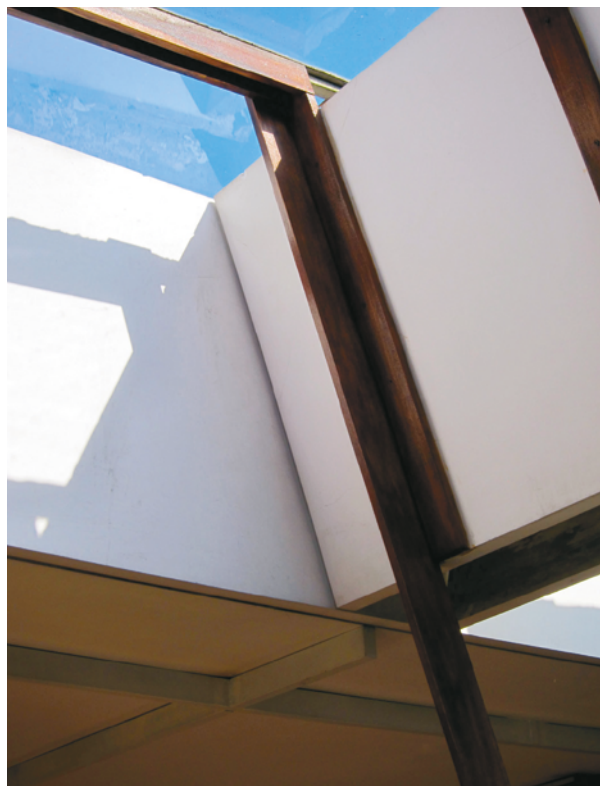
Figs. 0.16 a/b
Details of the skylight
in the taller cubic block.

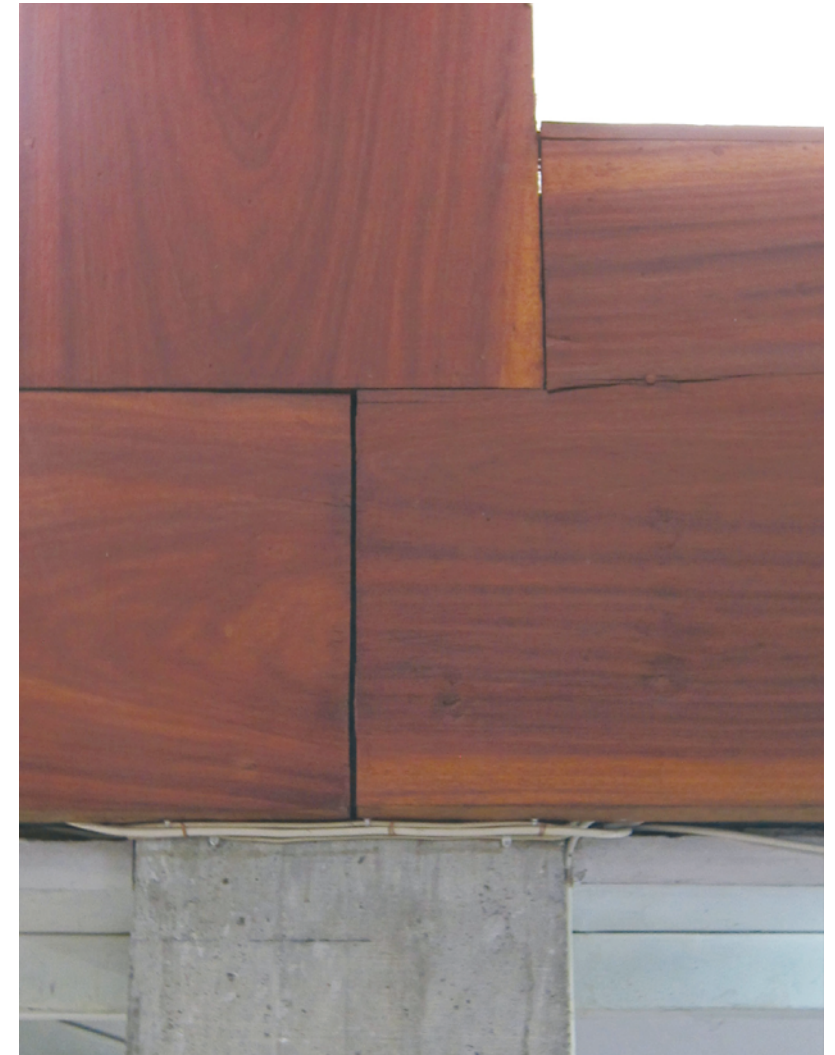
Fig. 0.21
Remnants of the original
wooden window frames.

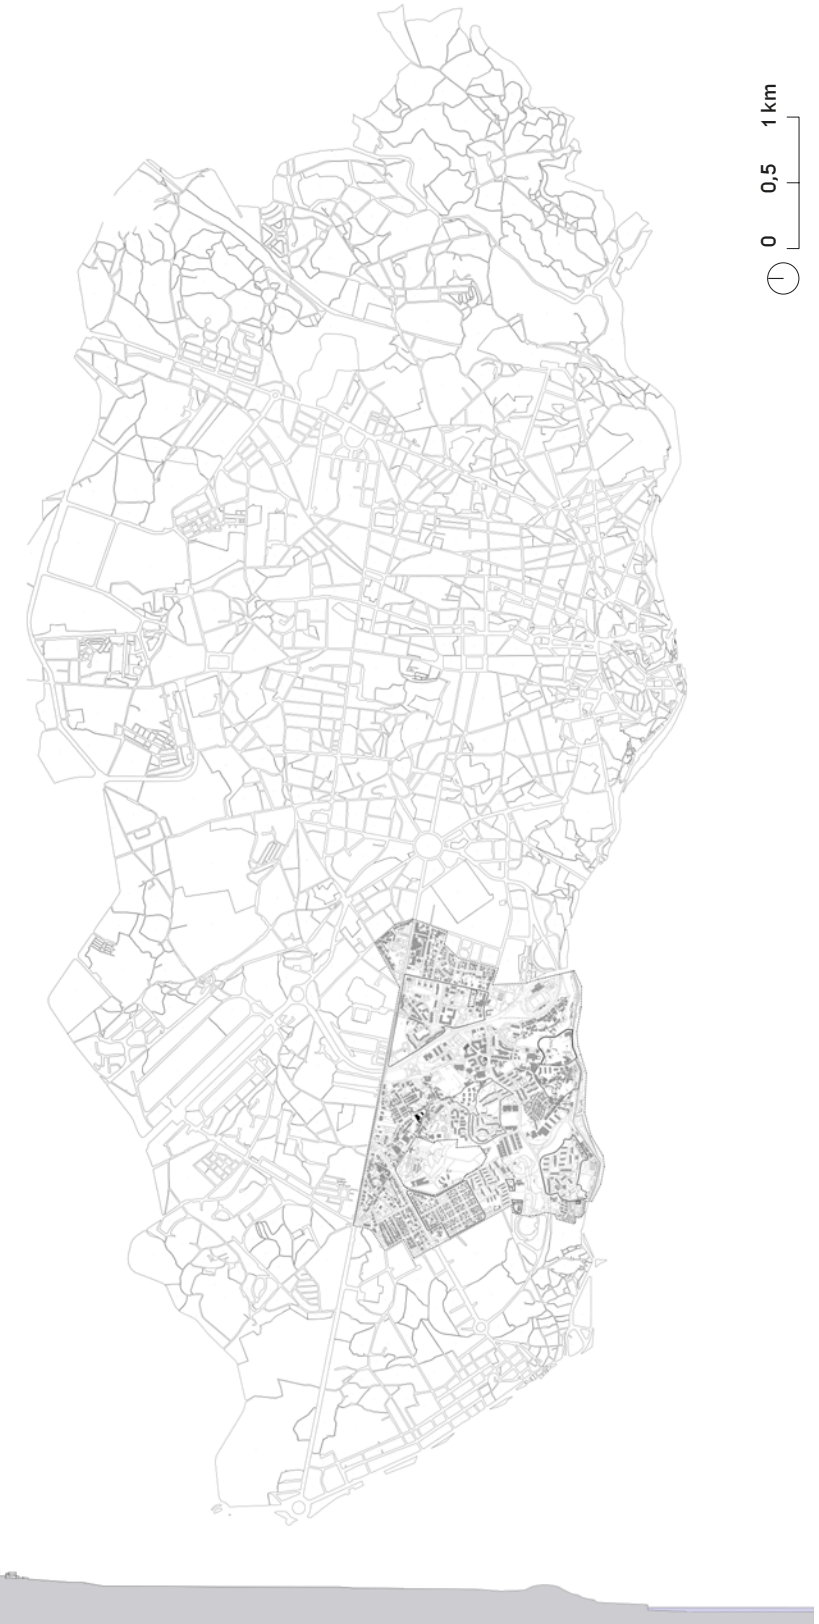
Fig. 1.2

Territorial section spanning from the Lordelo do Ouro Cooperative Building up to the bank of the Douro river (drawing by Júlio Ferreira).

Lordelo do Ouro neighborhood, in Porto, is located on the right bank of the Douro river; within this area, sloping down towards the river, the Cooperative Building occupies a triangular allotment at the intersection of the streets *Rua de Cima* and *Rua Professor Augusto Nobre* [Fig. 1.1 and Fig. 1.2].

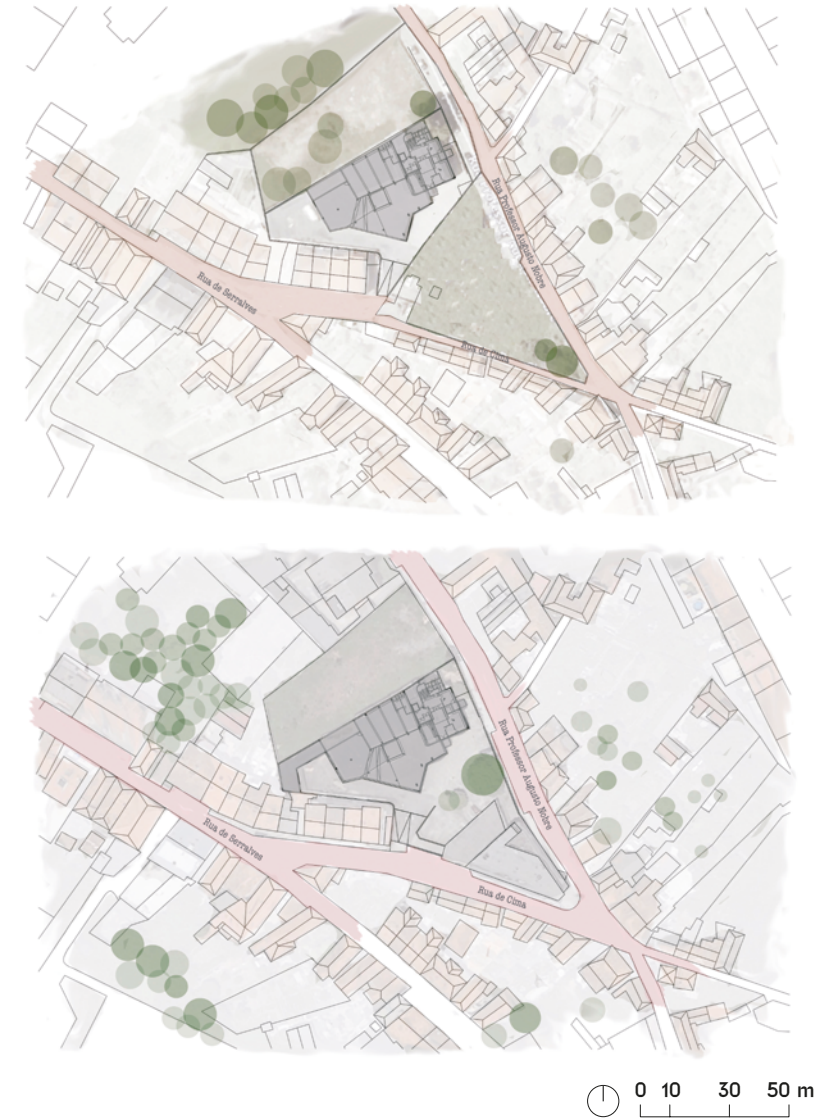
Fig. 1.5

Layout plan of the open space outside the Building as it was in its initial condition, in 1963 (top), and (down) after the 1984 alterations (drawings by Elsa Gonçalves).

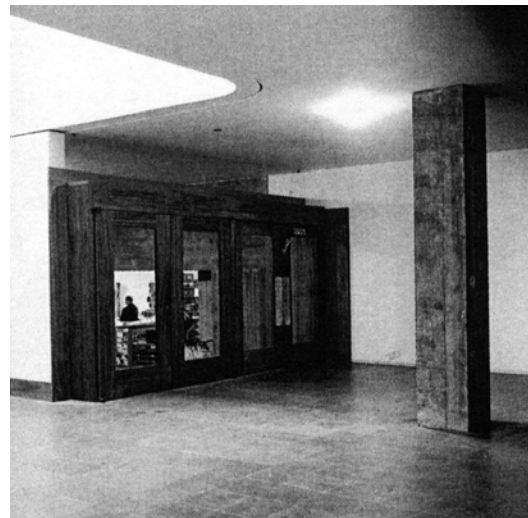
**Fig. 1.9 and 1.10**

Images (1960–63) of the three-story block and entrance lobby in their original configuration (Álvaro Siza © Archive Serralves Foundation).

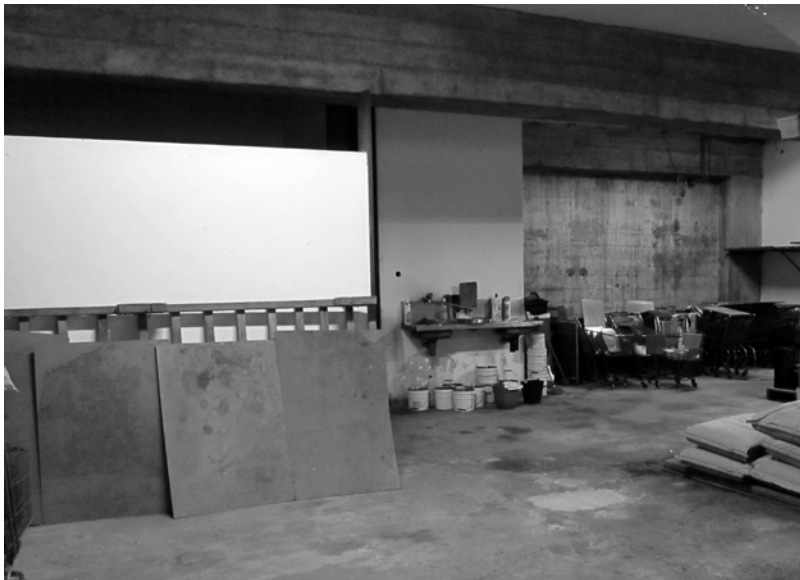
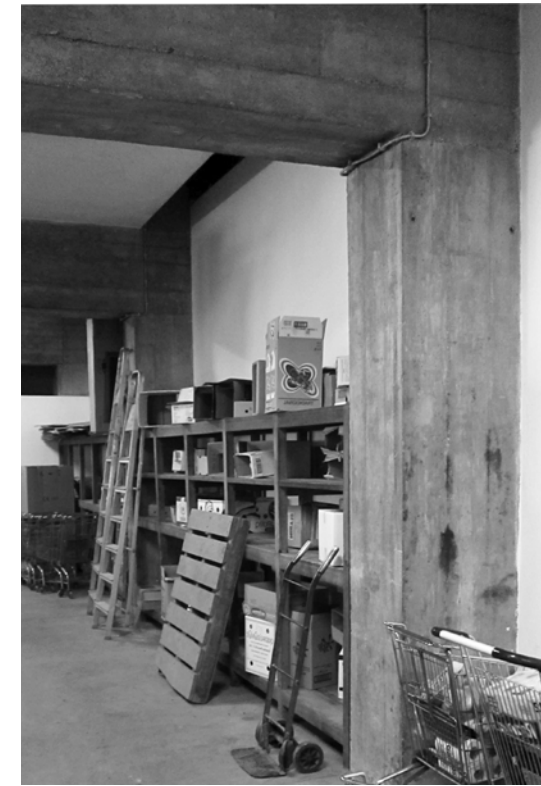
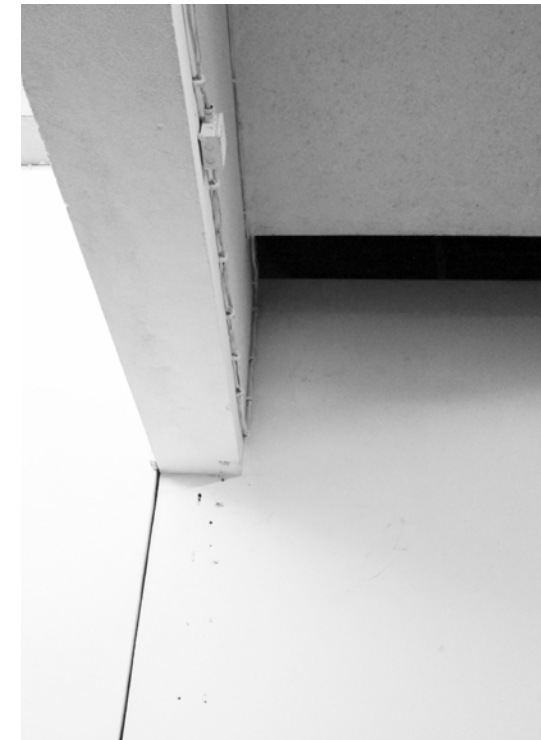
**Fig. 1.16 a/b/c**

Views of the storage room's northern wall, on top of which one can see the horizontal opening of the ventilation shaft (photos by the author 2017-19).

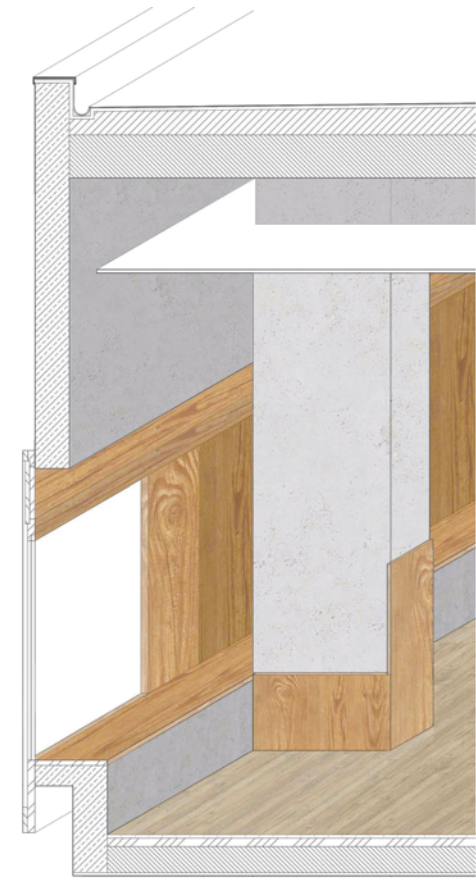
Fig. 1.19
Axonometric reconstruction with details of the materials used on the wooden framework of the assembly hall's façade wall as observed from the inside (drawing by Silvy Dias).

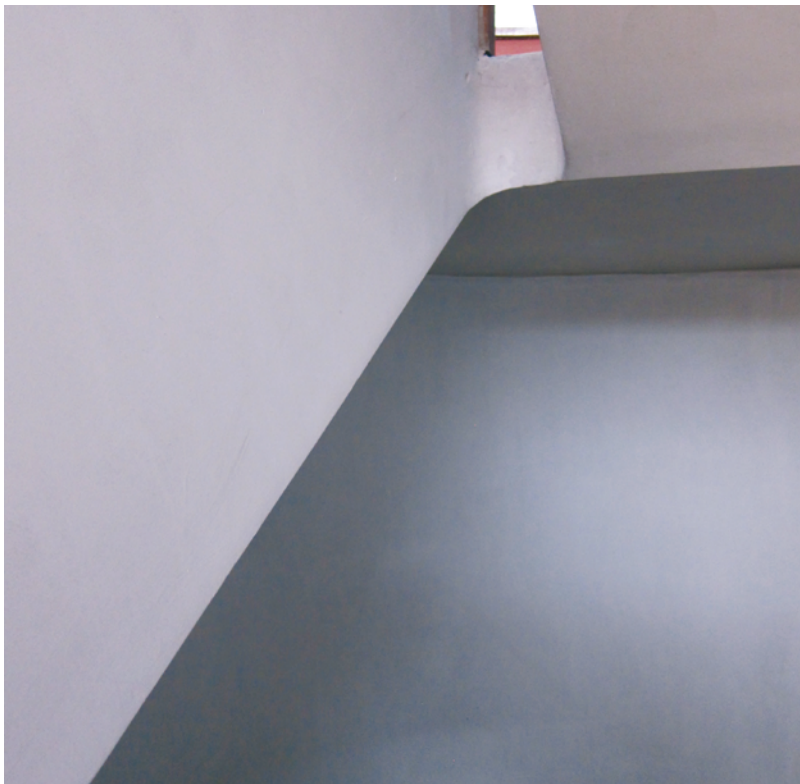
Fig. 1.22
Detail of the intradoses of
the staircase ramps (photo
by the author 2017–19).

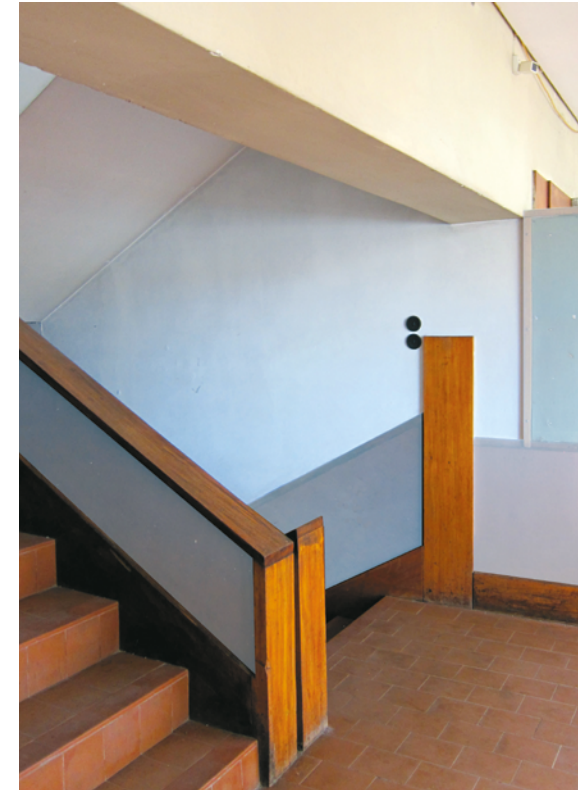
Fig. 1.23
Detail of the staircase
landing on the first floor
(photo by the author
2017–19).

Note regarding
Figures 1.23 and 1.26:
opacified white parts
correspond to the altered
ones, flooring materials
shown in those images
are also not the originals.

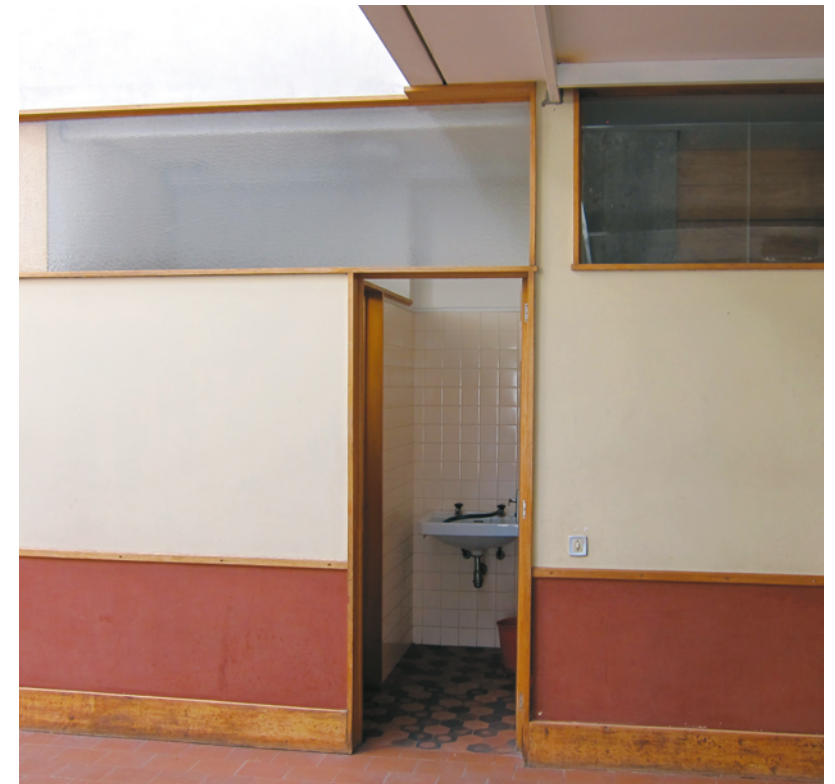
Fig. 1.24
View of one of the altered
restrooms on the first
floor (photo by the author
2017–19).

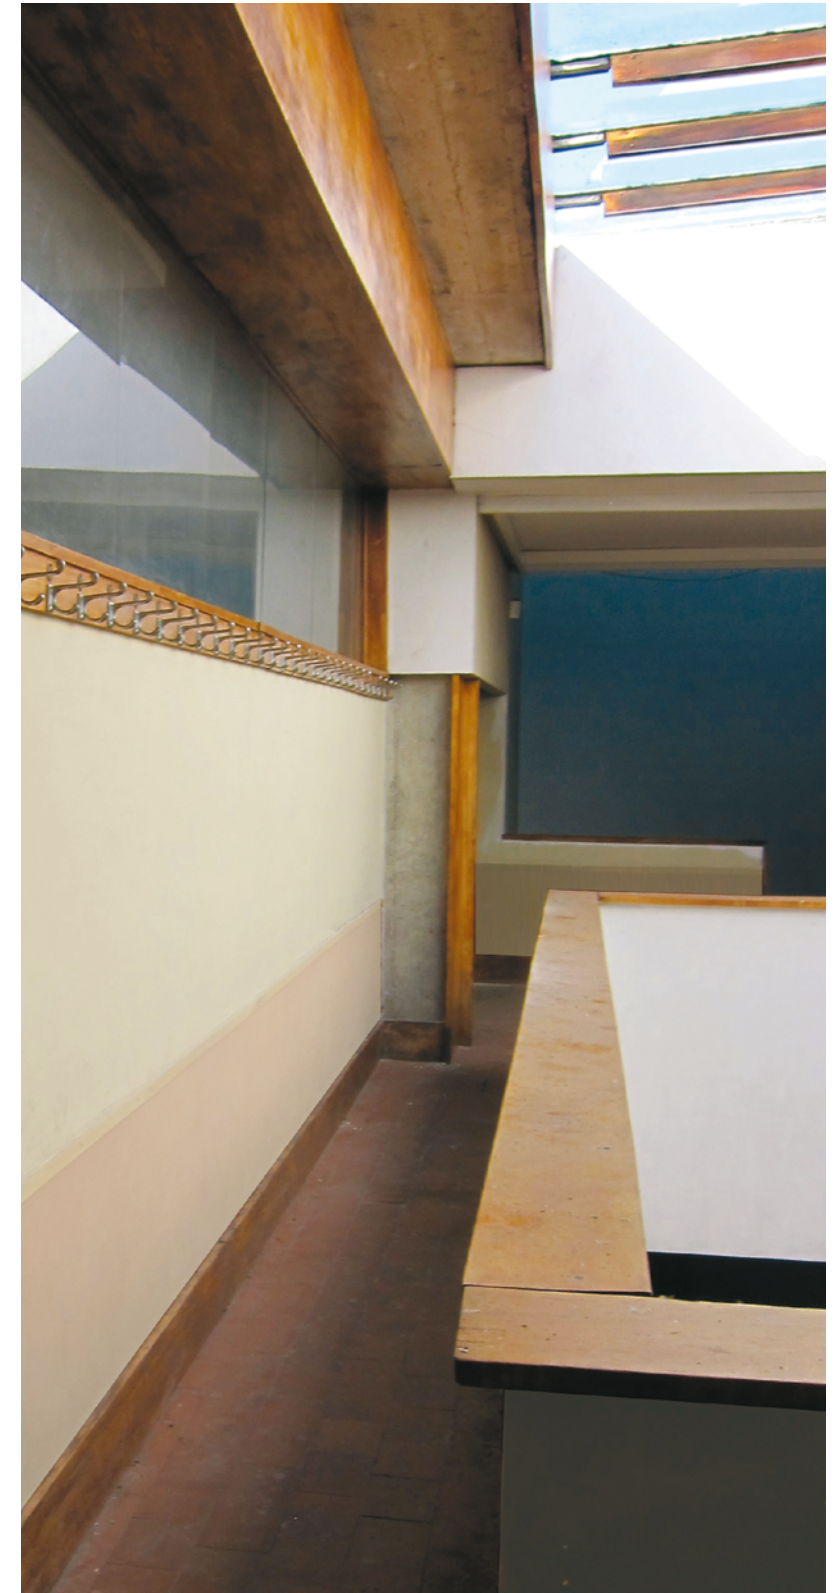
Fig. 1.26
Outside view of one of the library rooms on the second floor (photo by the author 2017-19).

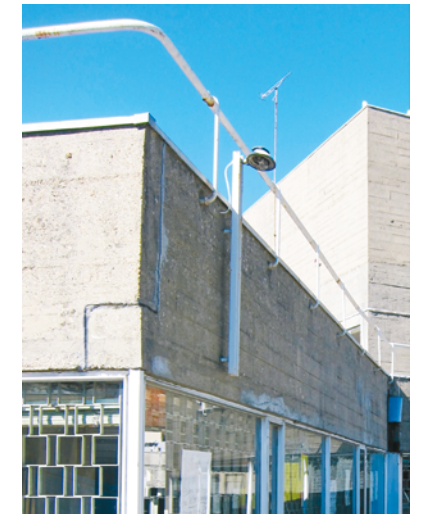
Fig. 1.31 and Fig. 1.32
 Present day condition, in detail, of the two joints portrayed in Fig. 1.30 (photos by the author 2017-19).
